Review

ZEKRYA BUR FRACTURE DURING EXTRACTION: HOW CAN THIS TYPE OF COMPLICATION BE AVOIDED? A LITERATURE REVIEW

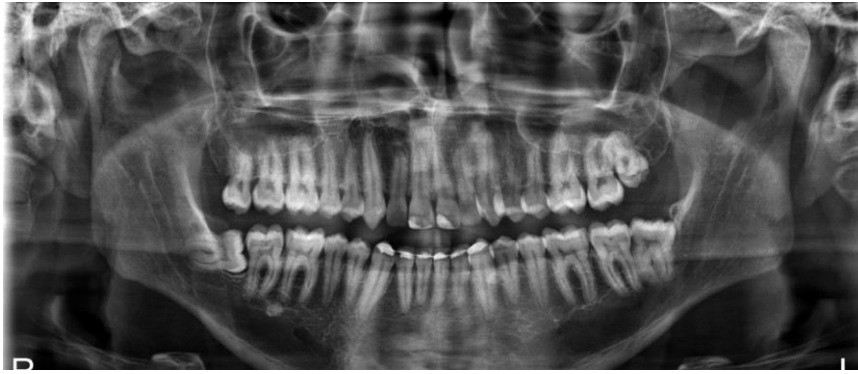
Fig. 1. Preoperative panoramic radiograph for lower and upper right third molar surgery.

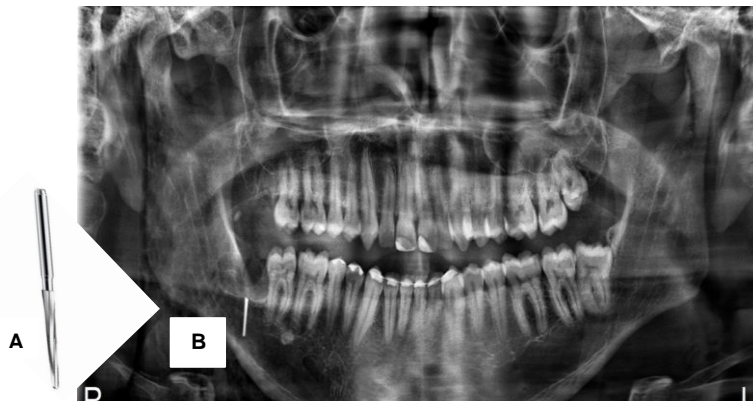
High-speed handpiece drills have high cutting efficiency, and dentists should always be aware of the possibility of causing overheating, subcutaneous emphysema, or breakage. Using worn burs without performing the correct movement and/or associated lack of adequate irrigation can lead to fracture during surgery. Occasionally, bur fragments not observed during surgery can cause complications, such as discomfort and infection after the procedure (Table III; Fig. 1, 2) (5).

Fig. 2. A): Zekrya bur; B): Post-tooth extraction overview showing fracture of the surgical bur.

To avoid this complication in daily clinical practice, the professional must use quality and reliable products, always respecting their correct movement. Additionally, pre- and post-operative periods of surgical instruments should always be checked.
